dsPIC30F2011/2012/3012/3013 Rev. A1 Silicon Errata

dsPIC30F2011/2012/3012/3013 (Rev. A1) Silicon Errata

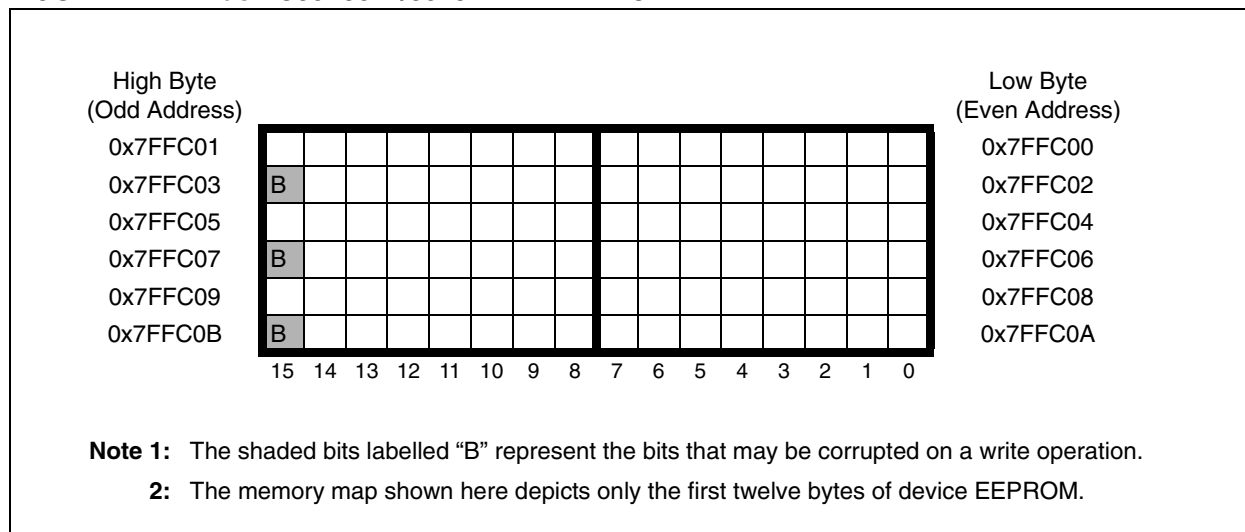
FIGURE 1: dsPIC30F3012/3013 DATA EEPROM

The Most Significant bit of every fourth byte in data EEPROM may be corrupted on any write operation. This write corruption may occur while using either PRO MATE®, MPLAB ICD 2 or Run-Time Self-Programming (RTSP).

Figure 1 shows the first twelve bytes in data EEPROM and indicates the affected bits.

Work Around 1:

Use program Flash memory instead of data EEPROM to store constant data.

Work Around 2:

Use less than 16 bits in each word in the available data EEPROM, excluding the Most Significant bit.

Work Around 3:

Avoid using every fourth byte. Example 1 shows how the ASM30 assembler can be used to allocate data in the EEPROM under this constraint.
