## dsPIC33EVXXXGM00X/10X Family Silicon Errata and Data Sheet Clarification

The dsPIC33EVXXXGM00X/10X family devices that you have received conform functionally to the current Device Data Sheet (DS70005144E), except for the anomalies described in this document.

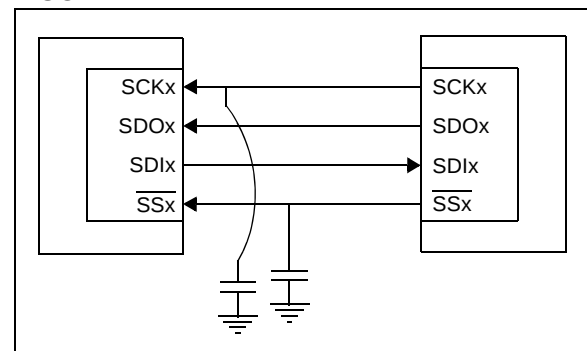
FIGURE 1:

When the SPIx module is configured in SPIx Slave mode (MSTEN bit (SPIxCON1<5>) = 0), the frame slave (FRMEN bit (SPIxCON2<15>) = 1) and the SPIFSD bit (SPIxCON2<14>) = 1), in Standard Buffer mode with the Clock Polarity Select bit, CKP = 0, the data is not transmitted in both 8-bit and 16-bit mode, but the data is being received correctly.

Adding a capacitance on the signal, as shown in Figure 1, will help the data to be received properly.

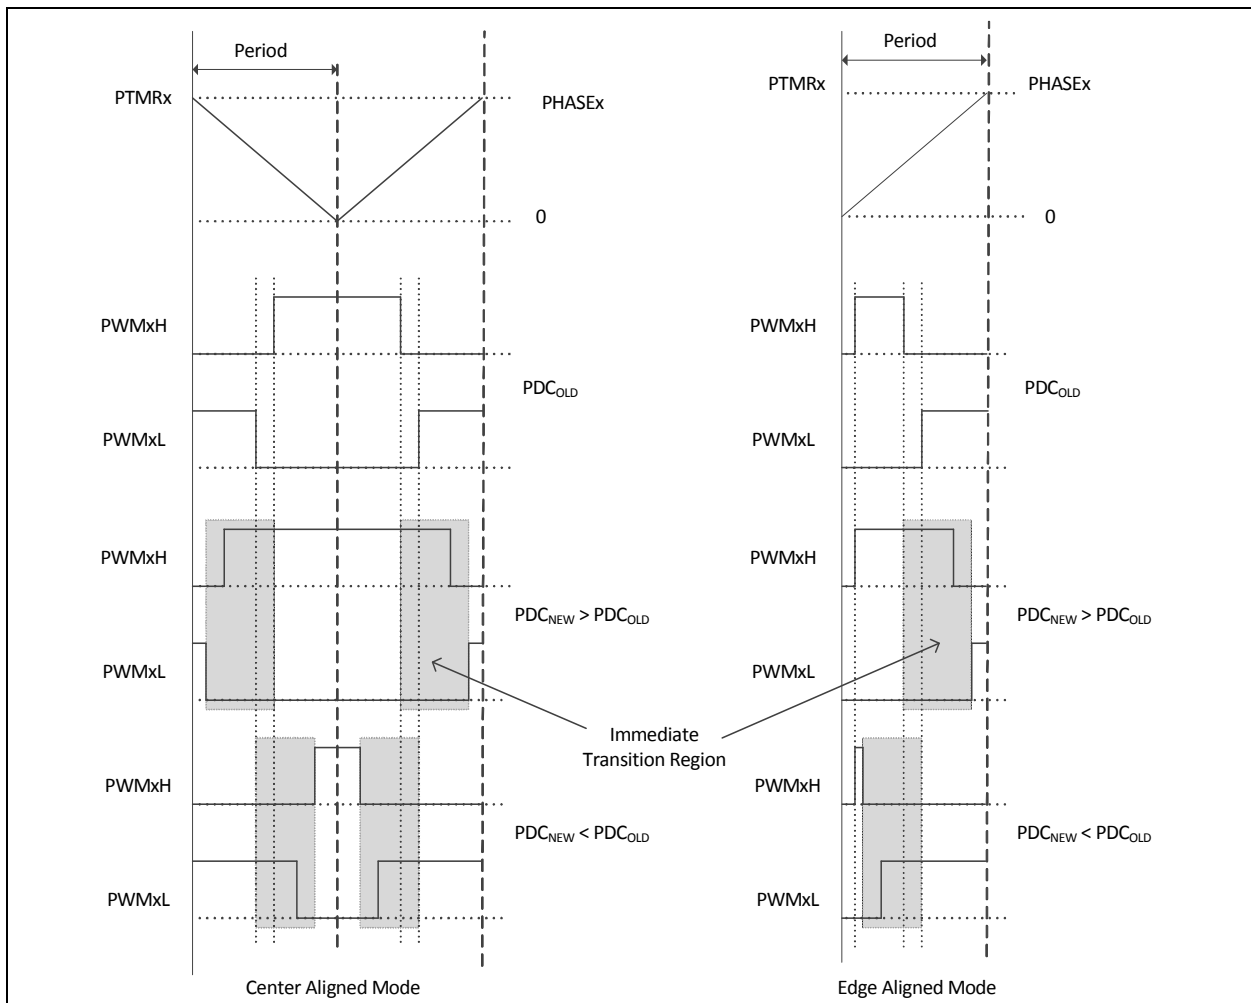
**FIGURE 2: TIMING DIAGRAMS FOR CENTER-ALIGNED AND EDGE-ALIGNED MODES**

The PWM generator may not assert dead time on the edges of transitions. This has been observed when all of the following conditions are present:

In [Figure 2](#), if the duty cycle write occurred in the shaded box, then PWMxH and PWMxL will make an immediate transition without dead time.

However, in most applications, the duty cycle update timing can be controlled using the TRIGx trigger or Special Event Trigger, such that the above mentioned conditions are avoided altogether.

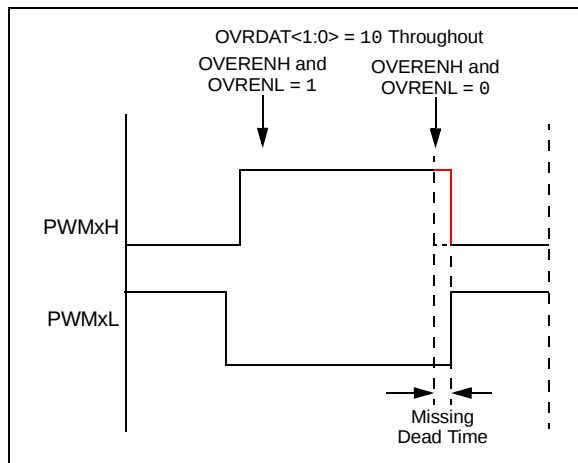
FIGURE 4:

- Output override synchronization is configured to occur on the CPU clock boundary (IOCONx<0> = 0);
- Both PWMxH and PWMxL overrides are enabled prior to the event (OVRENH and OVRENL are both '1'), and
- Both overrides are disabled (OVRENH and OVRENL are both '0') at the instant the dead time should be asserted (Figure 4). This has been observed in both Center-Aligned and Edge-Aligned modes.

None.

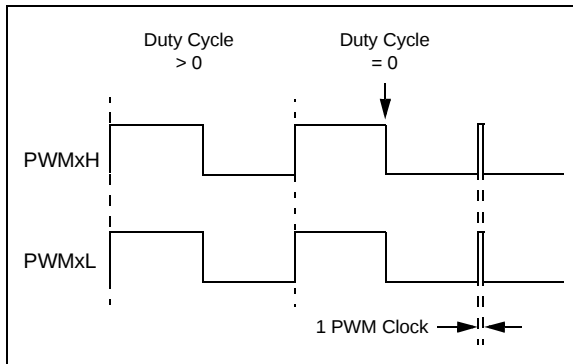
FIGURE 5:

In the Redundant Output mode (IOCONx<11:10> = 10) and Push-Pull Output mode (IOCONx<11:10> = 01) with Immediate Update disabled (PWMCONx<0> = 0), when the Duty Cycle register is updated from a non-zero value to zero, a glitch pulse of a width equal to 1 PWM clock will appear at the next PWM period boundary, as shown in Figure 5, for the Redundant Output mode. Here, the Duty Cycle register refers to the PDCx register if PWMCONx<8> = 0 or the MDC register if PWMCONx<8> = 1.

If the application requires a zero duty cycle output, there are two possible work around methods:

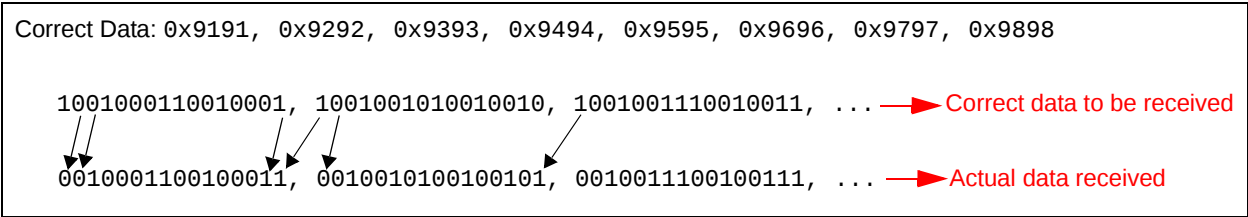
FIGURE 6:

Received data of the SPI is sampled one clock cycle late for the following conditions:

For example, the correct data that should be received is 0x9191, 0x9292, 0x9393, 0x9494, 0x9595, 0x9696, 0x9797, 0x9898, but the actual data received is 0x2323, 0x2525, 0x2727, 0x2929, 0x2B2B, 0x2D2D, 0x2F2F, 0x3130 (Figure 6).

None.
